Neck Injuries in Car Accidents - Causes, Problems and Solutions

Klaus Langwieder; Wolfram Hell

Verband der Schadenversicherer e. V. -VdS-

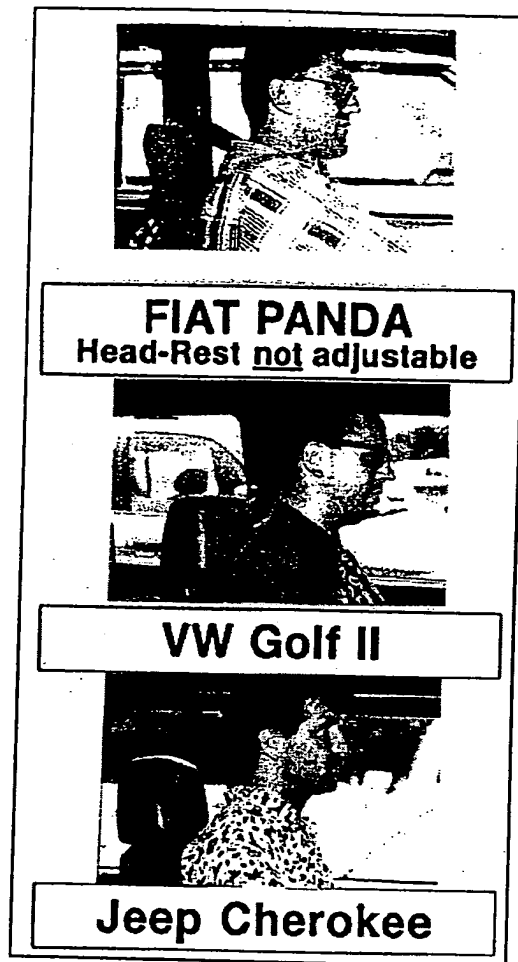
Figure 3: Examples of Insufficient Height-Adjustment/Geometry of Head-Rest

The typical present situation in many cars (especially for tall passengers) is demonstrated in Fig. 3.

These headrests fulfil the European construction standard ECE R17 [8] for headrests, which is about 20 years old. A seating test confirmed that tall persons could not be protected with the headrests of many cars. Although safety engineers know that the ECE R 17 norm is insufficient, the head-rest for a long time was the "forgotten safety feature" because no significant improvements could be observed. By looking at car advertisements and publications in technical journals about seat construction a lot of "wrong" head-rest positions could be observed [9]. Many car manufacturers pay more attention to cost limitation of head-rests instead of sufficient height-adjustment and horizontal distance.
